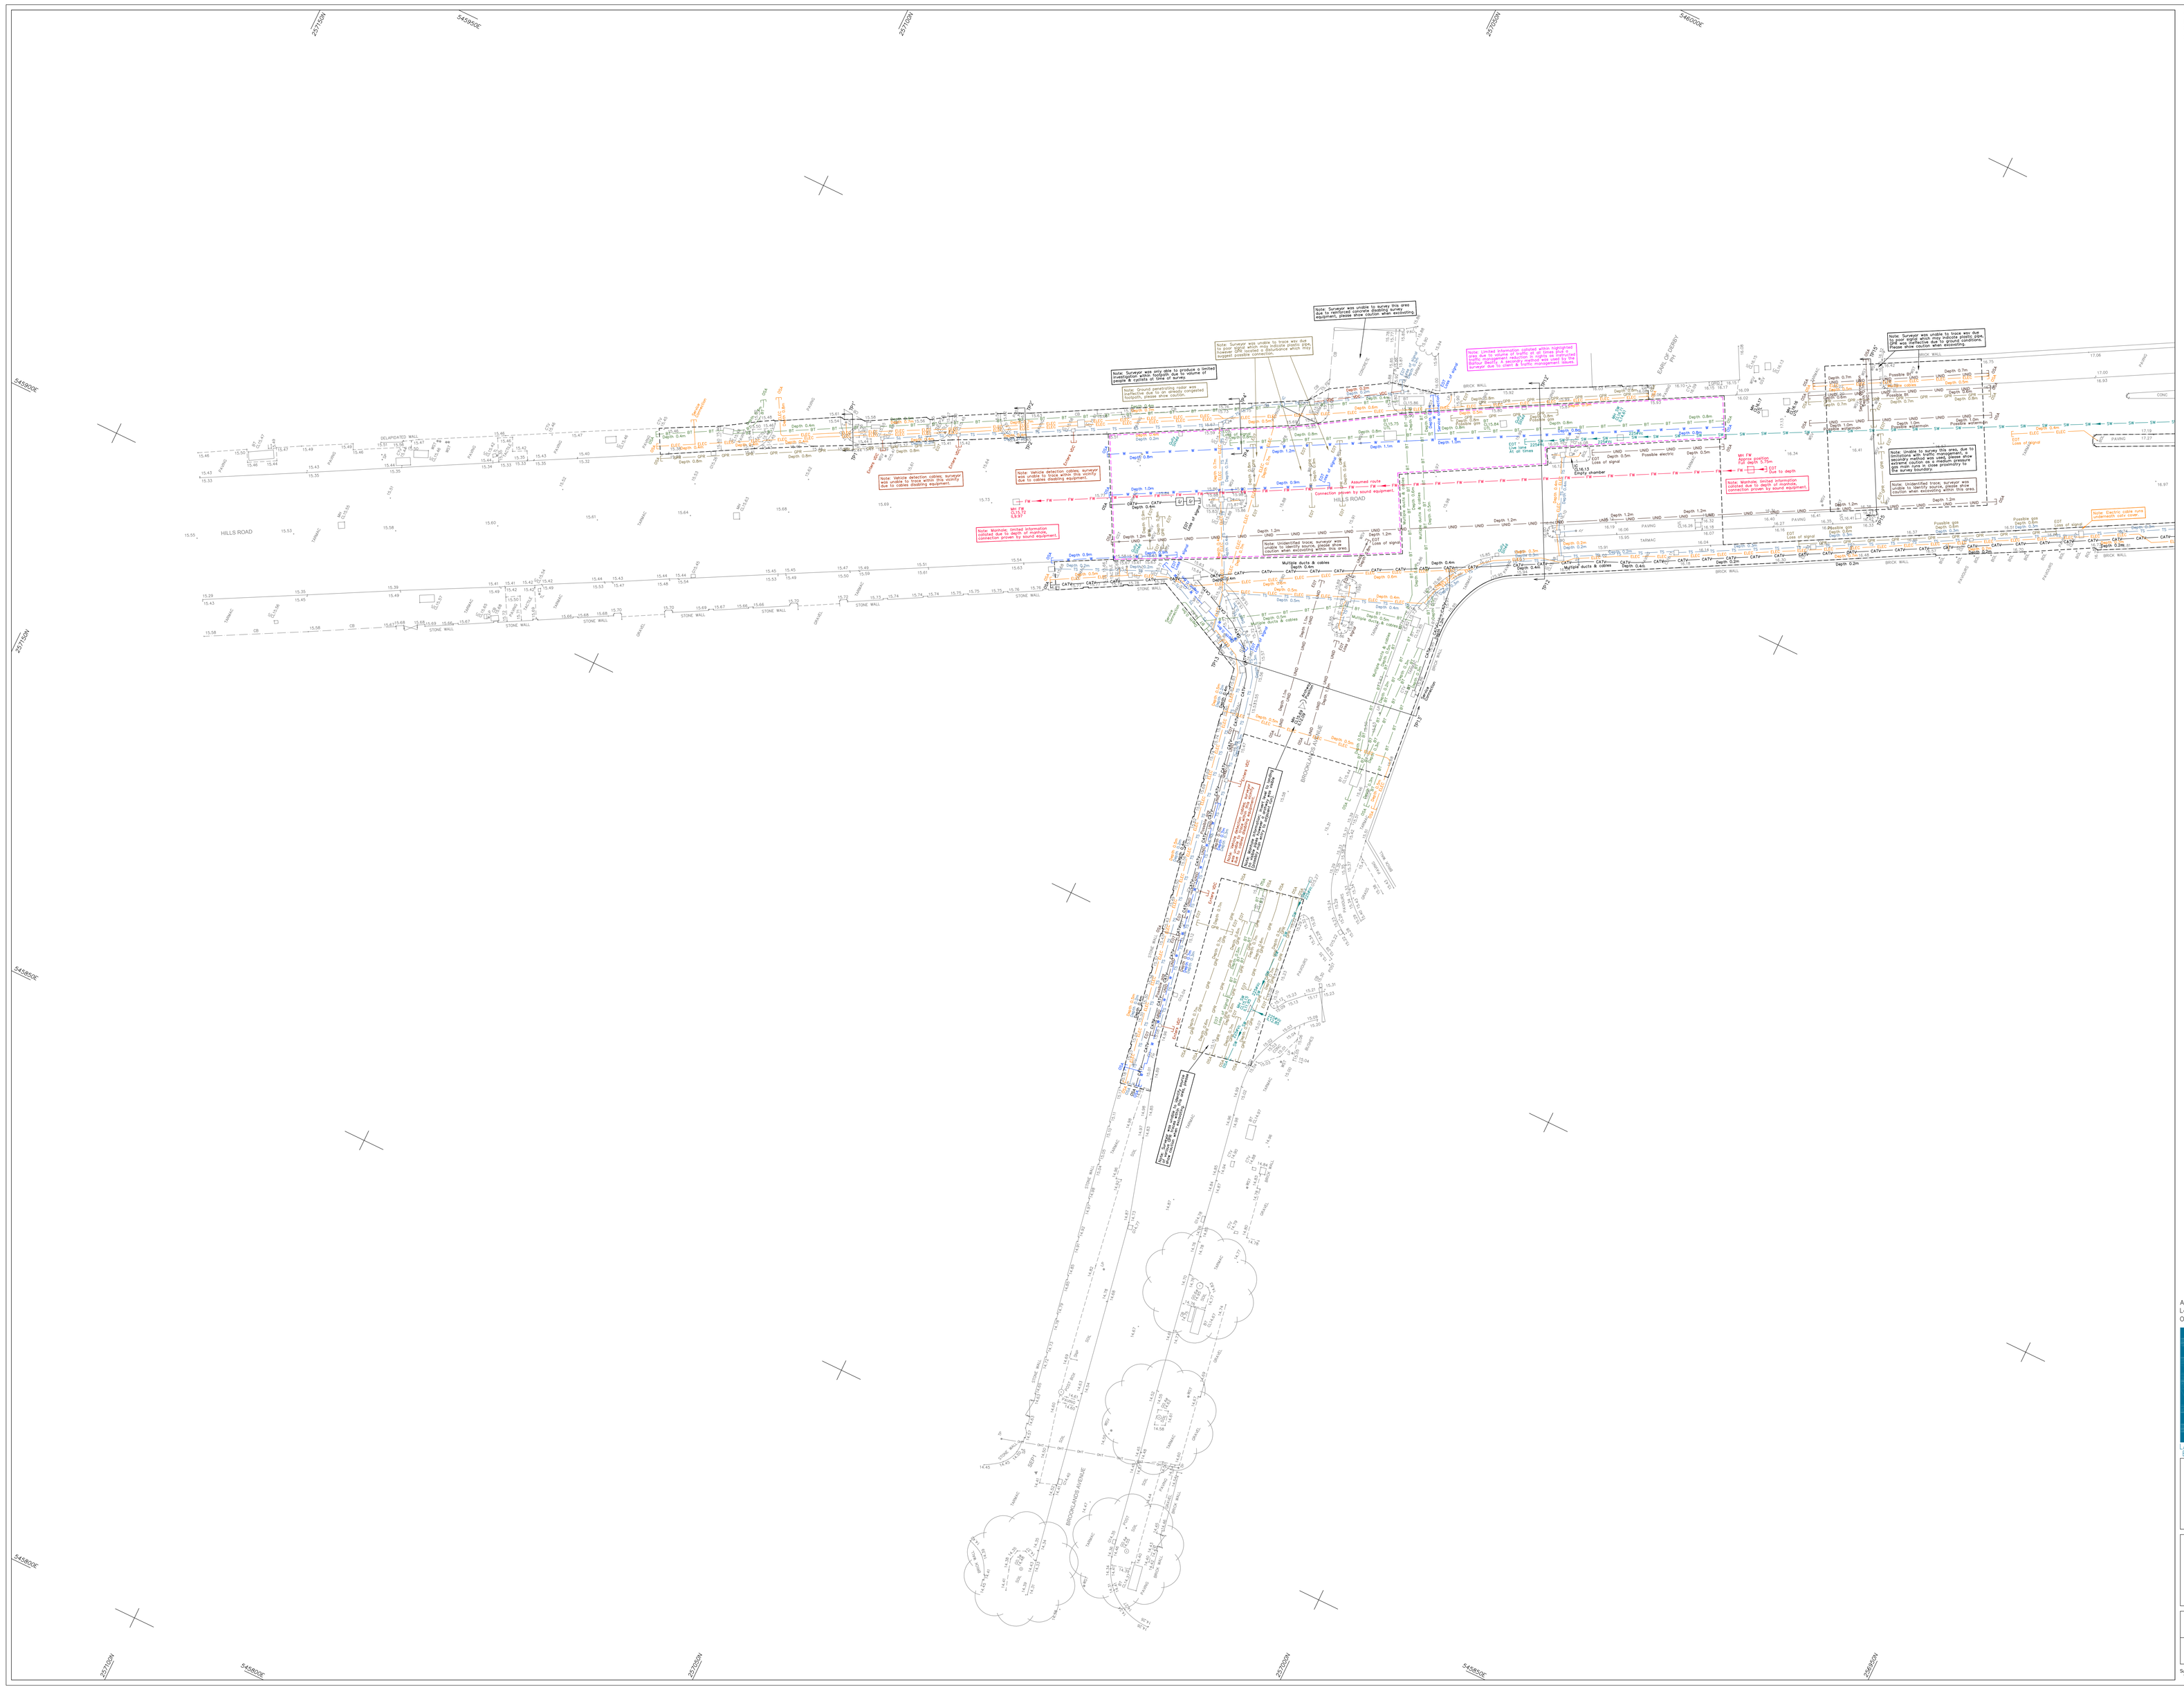
HILLS ROAD
BROOKLANDS AVENUE
Note: Surveyor was unable to survey this area due to restricted access. Possible gas equipment.
Note: Surveyor was only able to produce a limited survey due to the presence of people & cyclists on site at the time of survey.
Note: Surveyor was unable to trace any due to poor signal which may indicate a service that is present but not detectable using current equipment.
Note: Surveyor was unable to trace any due to poor signal which may indicate a service that is present but not detectable using current equipment.
Note: Various detection cables, surveyor was unable to trace some due to poor signal and cables masking equipment.
Note: Various detection cables, surveyor was unable to trace some due to poor signal and cables masking equipment.
Note: Various detection cables, surveyor was unable to trace some due to poor signal and cables masking equipment.
Note: Unidentified trace, surveyor was unable to trace some due to poor signal and cables masking equipment.

Note: Unidentified trace, surveyor was unable to trace some due to poor signal and cables masking equipment.
Note: Unidentified trace, surveyor was unable to trace some due to poor signal and cables masking equipment.
Note: Unidentified trace, surveyor was unable to trace some due to poor signal and cables masking equipment.
Note: Unidentified trace, surveyor was unable to trace some due to poor signal and cables masking equipment.
Note: Unidentified trace, surveyor was unable to trace some due to poor signal and cables masking equipment.
Note: Electric cable route underneath road surface.
Note: Surveyor was unable to trace any due to poor signal which may indicate a service that is present but not detectable using current equipment. Possible gas. Please drive caution when excavating
